FEMA RESCUES ROAD

**By: Donald H. Taubert
CAPITOL CEMENT**

February 2003

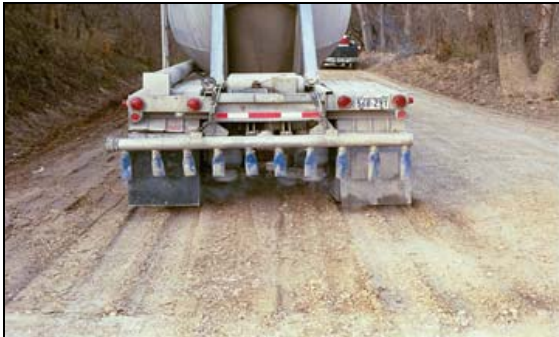
The first step was to reshape and establish drainage for the new roadway. The original roadway, built when no one has a memory of , had what appeared originally to be pit-run gravel for the base, though there wasn't much left. The road was salvaged from the ditches, banks and hillsides, and replaced back to its original grade.

After shaping with a CHAMPION Model 738 motor grader, portland cement was applied at the rate of 15 lbs./sq.yd. or about 3.5%.
