FEMA RESCUES ROAD

**By: Donald H. Taubert
CAPITOL CEMENT**

February 2003

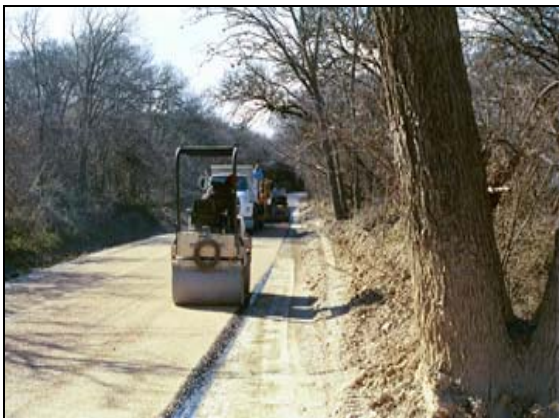
Mr. Alexander said: "Our city has mixed cement in limestone base material before to repair our roads as part of smaller projects in the past. Because of the good experience we've had using cement, we chose to use it again with the existing roadway to stabilize and strengthen it before paving. The project looks good, and is under evaluation to determine its role in our future recycling projects"
